**DEPARTMENT OF TRANSPORTATION****DIVISION OF ENGINEERING SERVICES**

Quality Assurance and Source Inspection

Contract #: 04-0120F4Cty: SF/ALA Rte: 80 PM: 13.2/13.9File #: 99.28**WELDING INSPECTION REPORT****Resident Engineer:**Siegenthaler, Peter**Address:** 333 Burma Road**City:** Oakland, CA 94607**Report No:** WIR-020521**Date Inspected:** 10-Dec-2010**Project Name:** SAS Superstructure**OSM Arrival Time:** 700**Prime Contractor:** American Bridge/Fluor Enterprises, a JV**OSM Departure Time:** 1900**Contractor:** Zhenhua Port Machinery Company, Ltd (ZPMC) Chanxing Island**Location:** Shanghai, China**CWI Name:** Mr. LIU HUA JIE**CWI Present:** Yes No**Inspected CWI report:** Yes No N/A**Rod Oven in Use:** Yes No N/A**Electrode to specification:** Yes No N/A**Weld Procedures Followed:** Yes No N/A**Qualified Welders:** Yes No N/A**Verified Joint Fit-up:** Yes No N/A**Approved Drawings:** Yes No N/A**Approved WPS:** Yes No N/A**Delayed / Cancelled:** Yes No N/A**Bridge No:** 34-0006**Component:** OBG Segment**Summary of Items Observed:**

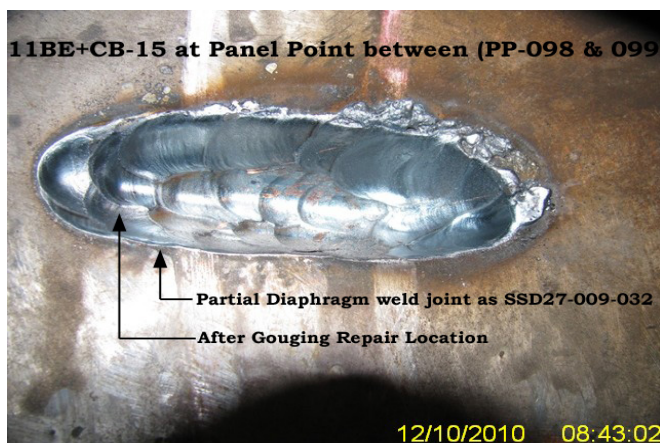
ZPMC welding personnel performing Shielded Metal Arc Welding (SMAW) of Repair weld for the partial diaphragm weld joint located on 11BE+CB-15 at Panel Point between (PP-098 & 099). The weld is designated as SSD27-009-032. The welder is identified as 044515. ZPMC QC Mr. ZHU YUAN YUAN was onsite monitoring the welding variables. The inprocess SMAW appears to be progressing in compliance with WPS-345-SMAW-2G (2F)-FCM-Repair-1. The weld repair report number is named as WR-18015. Further weld detail mention in attached picture.
